Manhole Inspection Summary

Manhole # S23I__012MH

Insp Date: **6/5/08 12:52 PM**

Location Address: **1435 Lemmon St**

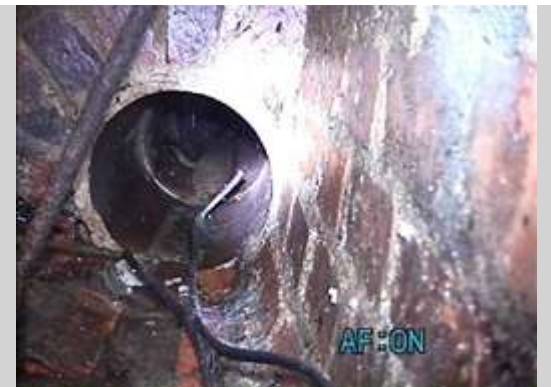
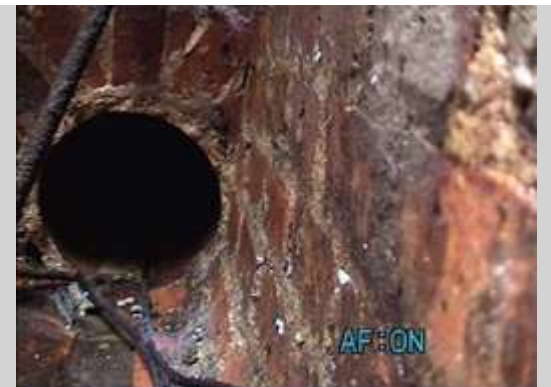
8 in. Circular Gravity Sewer
Pipe Out @ 12 OClock

Pipe Height: **8.4** (in.) Rod and Bar (Angled)
Pipe Material: **Clay** ☐ Pipe Lined
Invert Depth: **8.42** (ft.) Flow Characteristics: **None**
Deposits: ☒ None ☐ Mud ☐ Sludge ☐ Debris ☐ Grease
Silt Depth: **0** (in.) Deposits Extent:
Infiltration: **None** Pipe Seal Cond: **Sound**
